**PROPANE TRUCK COLLISION WITH  
BRIDGE COLUMN AND FIRE  
WHITE PLAINS, NEW YORK  
JULY 27, 1994**

**HIGHWAY ACCIDENT REPORT**

**Adopted: November 14, 1995  
Notation 6479A**

**NATIONAL  
TRANSPORTATION  
SAFETY BOARD**

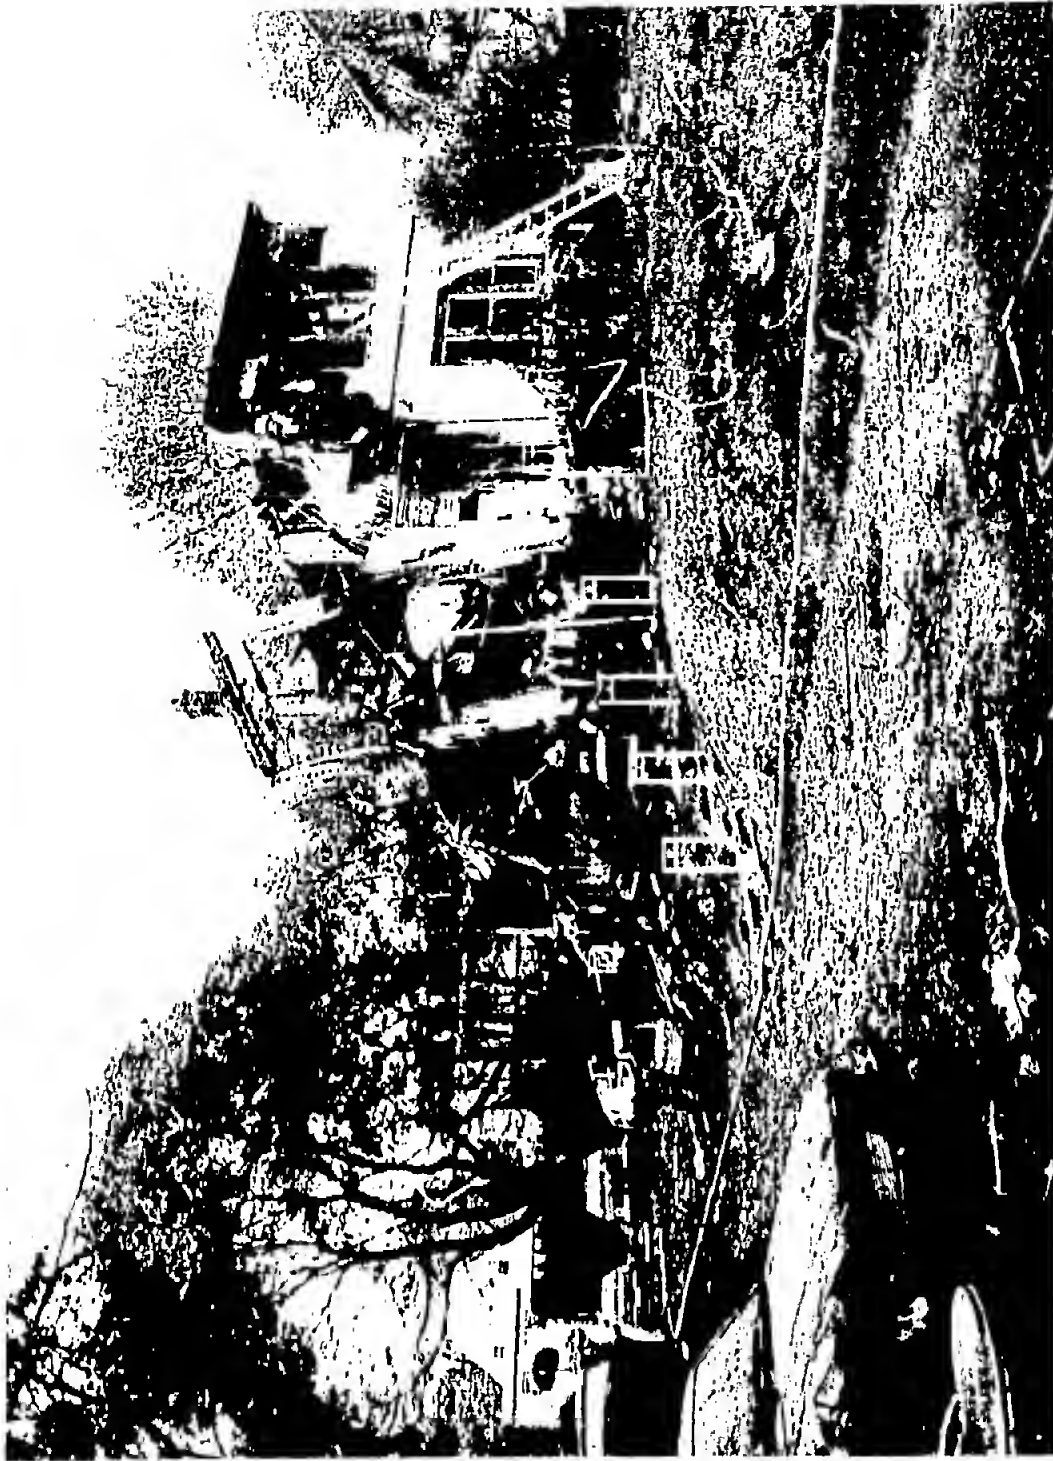
**Other** -- All lanes of the Cross Westchester Expressway between exit 6 (Broadway) and exit 8 (Westchester Avenue) were closed to traffic for 23 hours. The damage to the residences and parked cars in the neighborhood was estimated to be approximately \$1.7 million. (See figures 7 and 8.) The White Plains fire department estimated the cost of the emergency response to be over \$100,000.

Figure 7. — Fire damage at 77-81 Grant Avenue (Photo by Mike Horn)

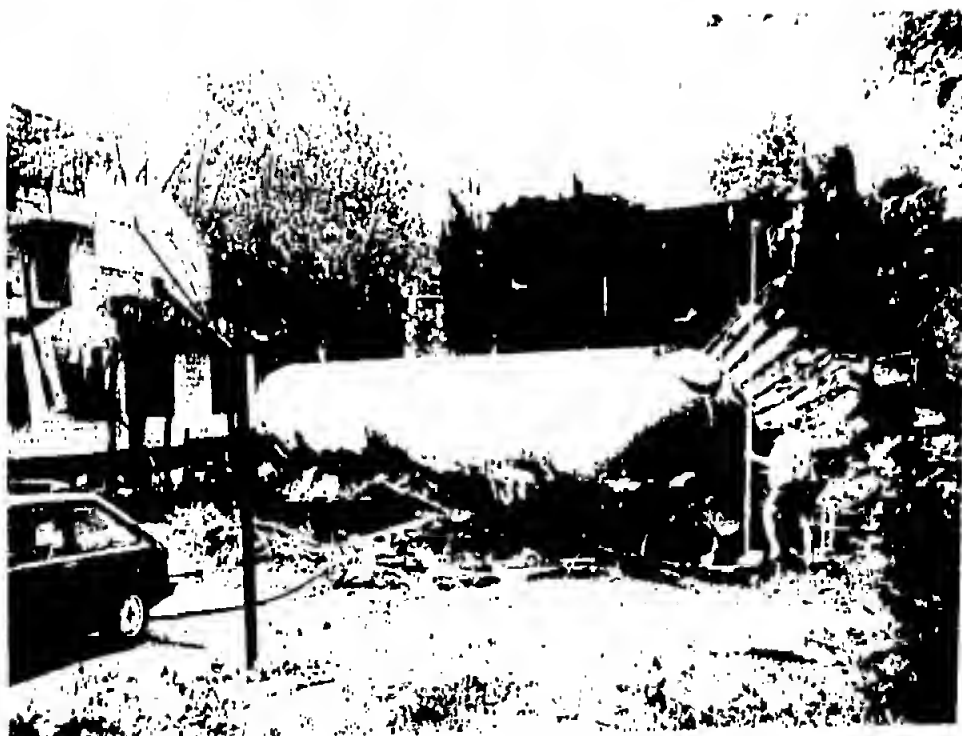
**Tank --** The amount of crush in the front head was about 21 inches. The separation was between the 9 and 2 o'clock position, looking aft (where the 12 o'clock position is defined as the top of the cylinder) along the heat-affected zone of the weld. The fracture then left the circumferential path and extended forward in the cylinder head and returned to the 9 o'clock position. (See figure 9.)

Figure 9. – Front and rear views of tank at rest at 103 Clinton Street  
(top photo by Mike Horn; bottom photo by Chas. H. Sells, Inc.)

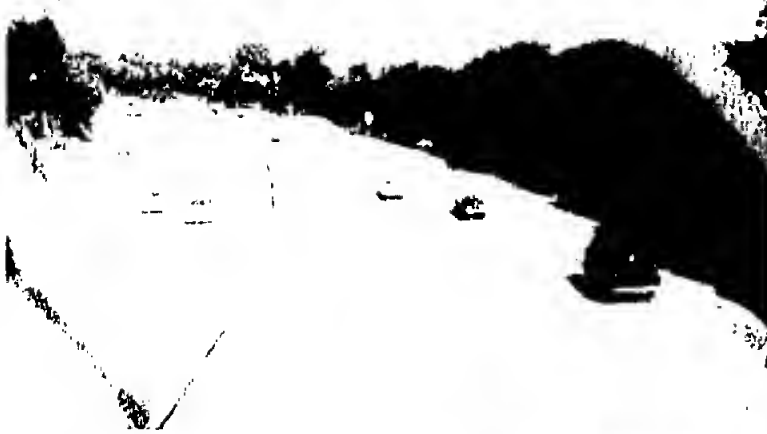
A -- Looking west from Grant Avenue overpass at box beam guardrail

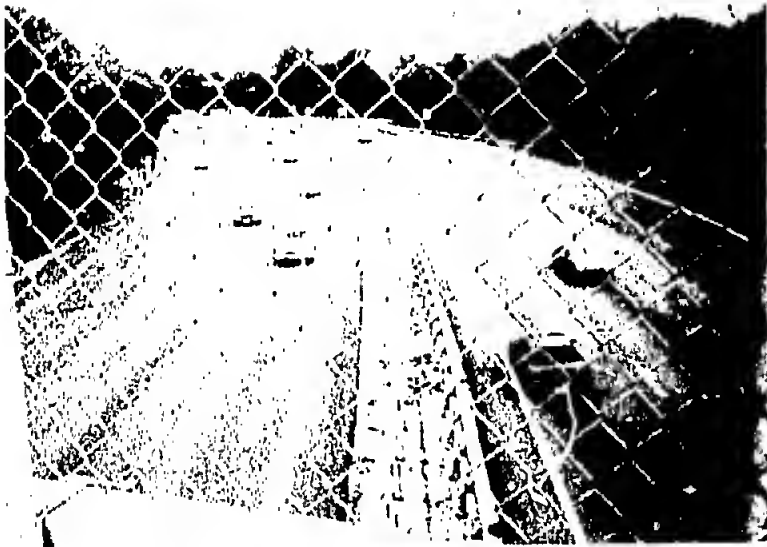
B -- Looking west from Grant Avenue overpass at strong post block-out guardrail

The blocked-out W-beam (strong post) barrier system in place at the time of the accident was a standard design that had been used by the NYSDOT since 1979. After the accident, the guardrail was replaced with another guardrail of the same design. This system is the most common barrier system in use today, but it was designed primarily to protect passenger cars by redirecting them from roadside obstacles. It is classified as an operational semi-rigid system by the AASHTO *Roadside Design Guide*, which means that it has demonstrated satisfactory field performance in terms of construction and has been successfully crash tested for automobiles.<sup>34</sup> In crash tests, this barrier was marginally successful in redirecting two pickup trucks weighing 3,260 and 4,179 pounds, respectively.

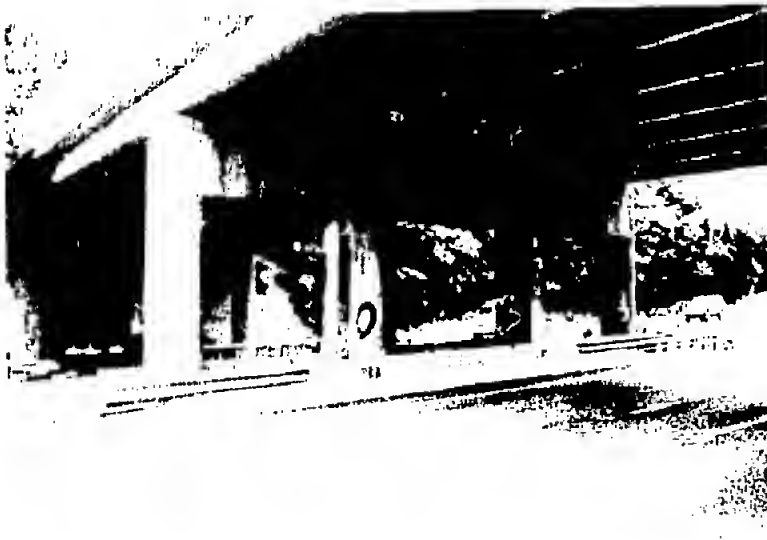
C -- Attachment of W-beam guardrail to concrete barrier
